ETHIOPIA

Observations on Buildings Made of Perishable Materials: Archaeological Traces of Demolition and Restoration of *Tukuls* at the Archaeological Field Camp at Melka Kunture, Ethiopia

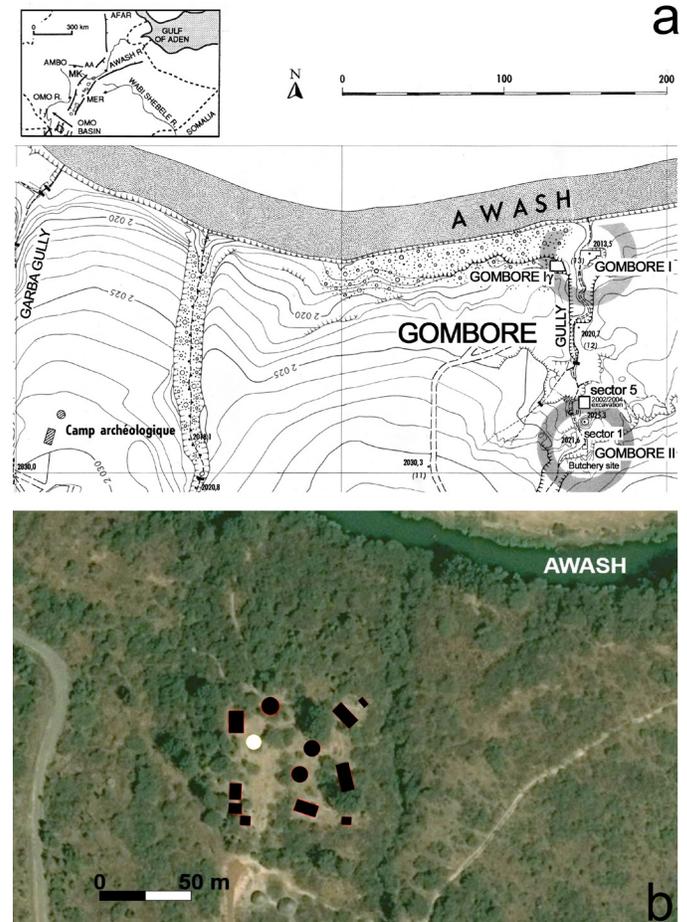
Figure 1: The archaeological camp at Melka Kunture: a) The camp’s location in 1970, based on Egels’ 1971 topographic map; b) satellite photo of the camp (based on Google Earth), showing the area of the present-day buildings (in black) and of the old *tukul* (in white).

In the past, other buildings stood at the campsite. Today they no longer exist, but their presence is documented and their history fairly well known. They include the first two buildings to be erected, and shown on the first topographic map of the area made by Y. Egels (Egels 1971). One was rectangular, and the other a round *tukul* (Figure 1a).

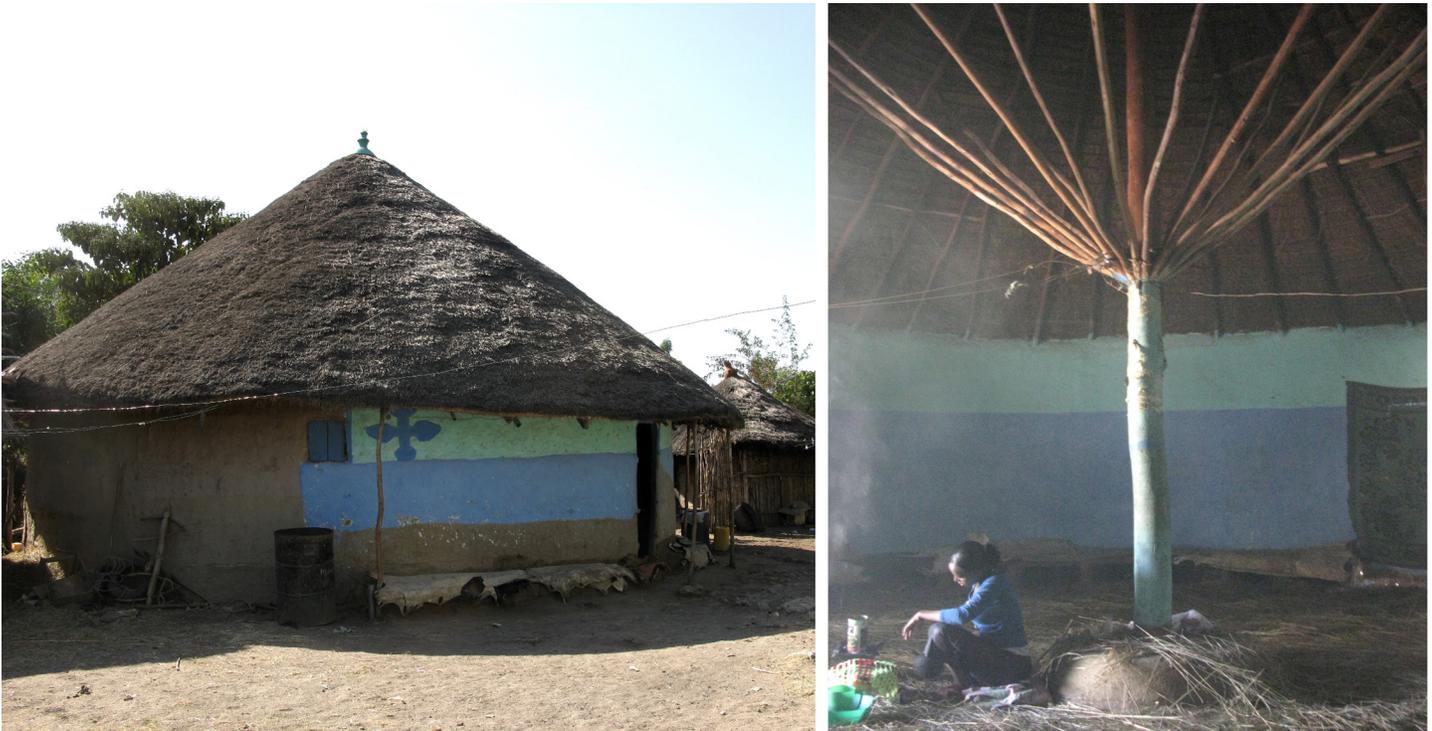
Figure 2: *Tukul* in the Melka Kunture area (Kella district): view of the outside and detail of the interior.

Tukuls are traditional dwellings in East Africa and similar constructions are common in many other African regions. In Ethiopia (Gebremedhin 1971), most *tukuls* are round and have conical roofs (Figure 2). The circular wall consists of a clay-and-straw mixture (daub) spread over a frame made of upright poles set close to each other and interwoven with branches. The roof is made of poles and canes running radially from the top of

the roof and bound with concentric lengths of rope. Inside the hut, the roof is braced by a central upright wooden post and a small circular frame of slanted poles that discharge part of the roof's weight to the floor (Figure 2). The roof is thatched with bundles of dry grass arranged starting from the base, and it is usually topped by a curved terracotta tile. The roof extends about 50 cm beyond the clay-covered wall so as to protect it from the weather. The floor is of packed earth, sometimes covered with mats made of plant materials.

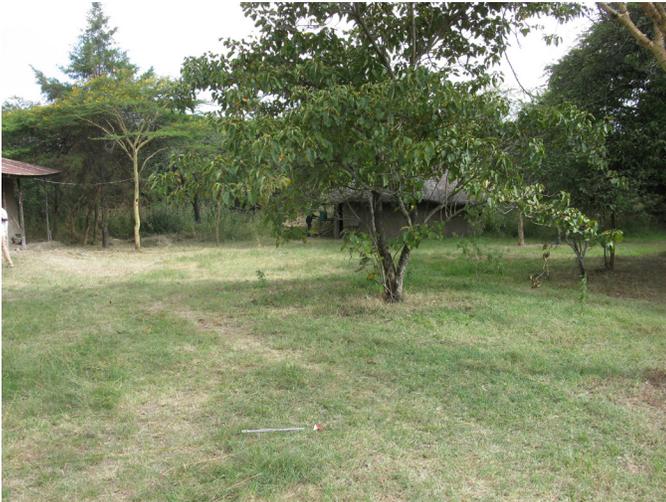
Figure 3: The Melka Kunture archaeological camp. In the foreground is the mound left from the decay of the old *tukul*; in the background is the restored *tukul*.

During the 2013 excavation season, in the central-western part of the camp we noticed a flat circular rise of the ground, around 15-30 cm high, about 7.5 m in diameter, and slanting slightly to the north (Figures 3 and 4). A concentric depression ran along the inside of the perimeter, forming a furrow about 1.2 meters wide and about 10 cm deep.

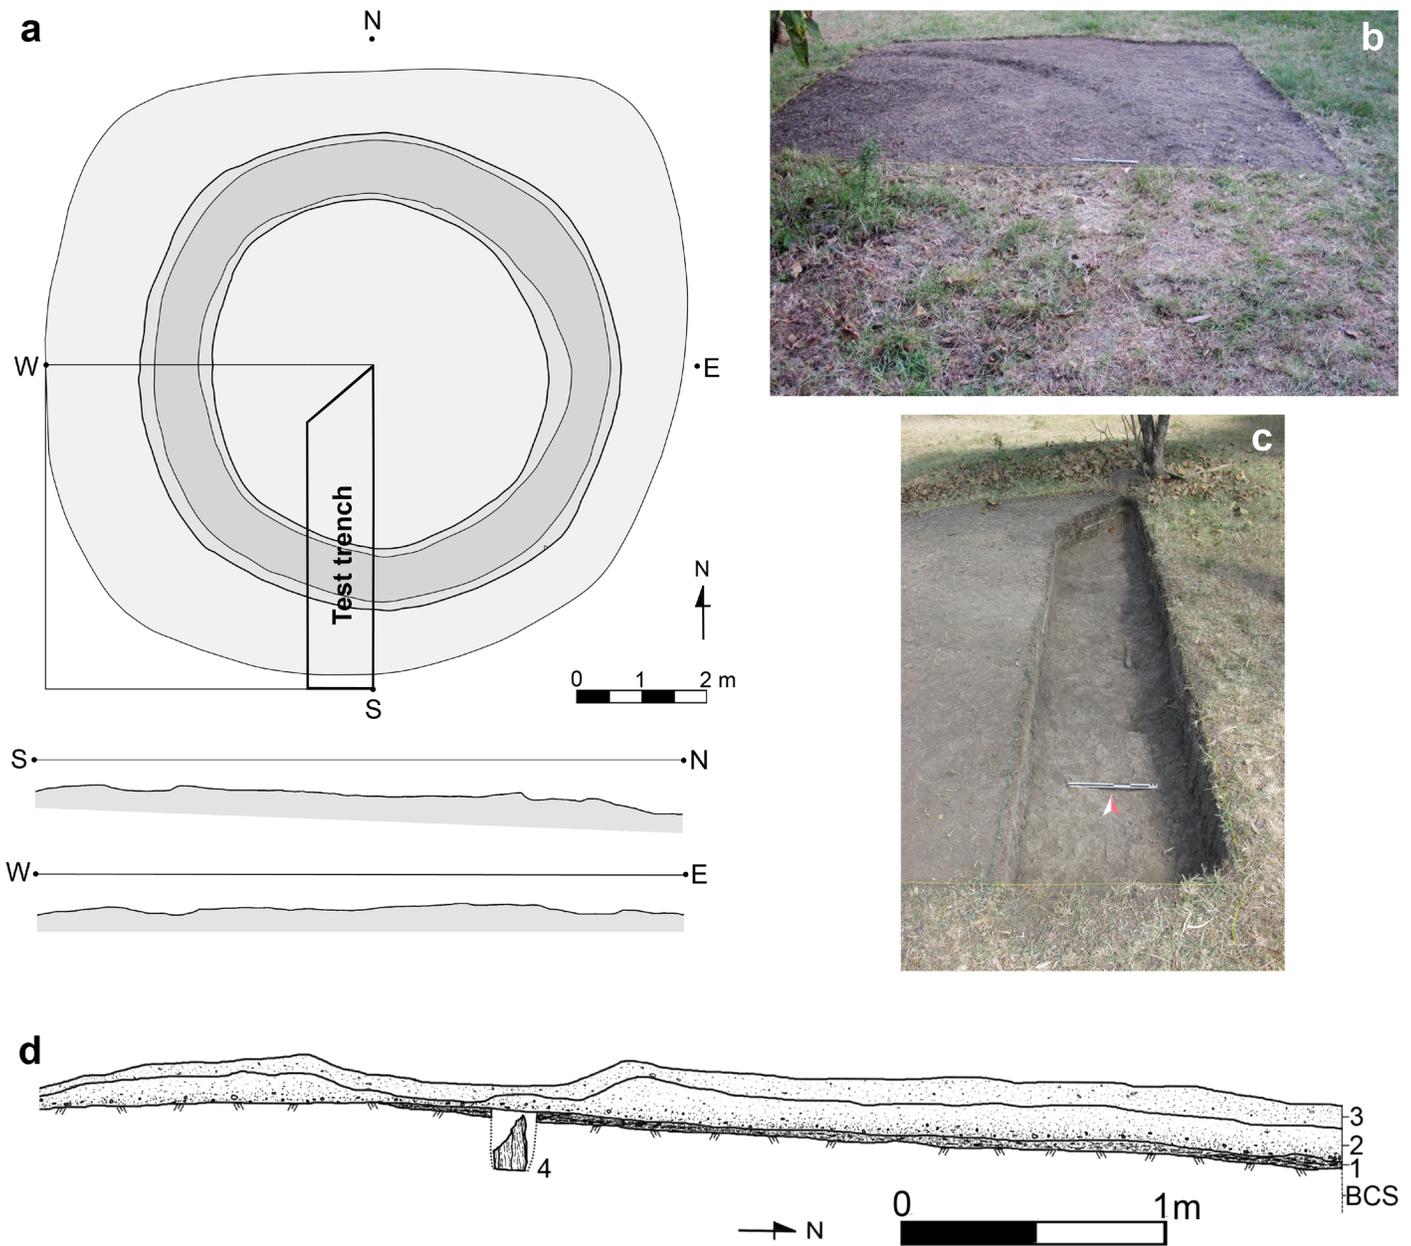
Figure 4: Archaeological investigations of the old *tukul*: a) planimetric map showing the location of the dig and the elevation profiles (S-N, W-E); b) view of the mound’s quadrant from the north after the ground was cleared; c) view of the excavated trench from the south; d) stratigraphic profile of the sequence identified on the west side of the trench.

We decided upon an archaeological investigation of the *tukul*'s remains. We drew a planimetric map of the site and divided it into four quadrants (Figure 4a). We then removed the vegetation in the SW sector, clearing the circular depression (Figure 4b). On the eastern side of this sector, we dug a stratigraphic trench one meter wide

that exposed the sequence of levels along a radial axis (Figure 4c).

The quite simple stratigraphic sequence consists of four superimposed levels and is characterized by the presence of a series of furrows (Figure 4d). The mound lies above a dark brown clayey-sandy Holocene layer that is found throughout the Melka Kunture area. This layer, known as Black Cotton Soil (BCS, Figure 4d), was

On top of the BCS is a layer of compacted earth (Figure 4d:1), only a few centimeters thick, consisting of clay mixed with volcanic tuff (which outcrops a few dozen meters away). It was probably spread (perhaps after smoothing out the BCS surface) to strengthen the *tukul*'s floor. It is also possible, though, that it was formed accidentally. The inert materials needed for the daub would have been piled up on the site and later mixed and spread on the hut's wall: part of them may have scattered and formed this layer. Based on the stratigraphic evidence, this layer precedes the building of the wall, because it contains holes in which the wall poles would have been inserted. In fact, we found a curved row of stratigraphic disturbances beneath the circular depression on the surface of the mound. They were certainly created when the upright wall poles were sunk into the ground. At the bottom of the excavation trench, we also found a pole stump still in place (Figure 4d:4).

Above the packed-earth layer is a clayey-sandy layer containing fairly large amounts of gravel and ignimbrite sediment (Figure 4d:2). The surface of this layer is marked by the circular furrow corresponding to the line of the old wall. This layer is most likely what remains of the daub used to coat the wooden structure. Part of this clay would have been deposited due to the deterioration of the *tukul* after it was abandoned (cf. the observations in McIntosh 1974, 1977; Badey 2001), but most of it would have accumulated when the building was torn down, in 1994; in fact, this layer is thicker along both sides of where the old wall stood. A depression corresponding to the line along which the wall poles were is probably where workers dug to retrieve the wooden reusable poles; it was later filled up with material left over after the hut was demolished.

This level, which we could call the "destruction level," is topped by the highest layer: a clayey pedogenized low mound (Figure 4d:3) that was probably a natural deposit of sediment that buried what was left of the old structure but followed its morphology.

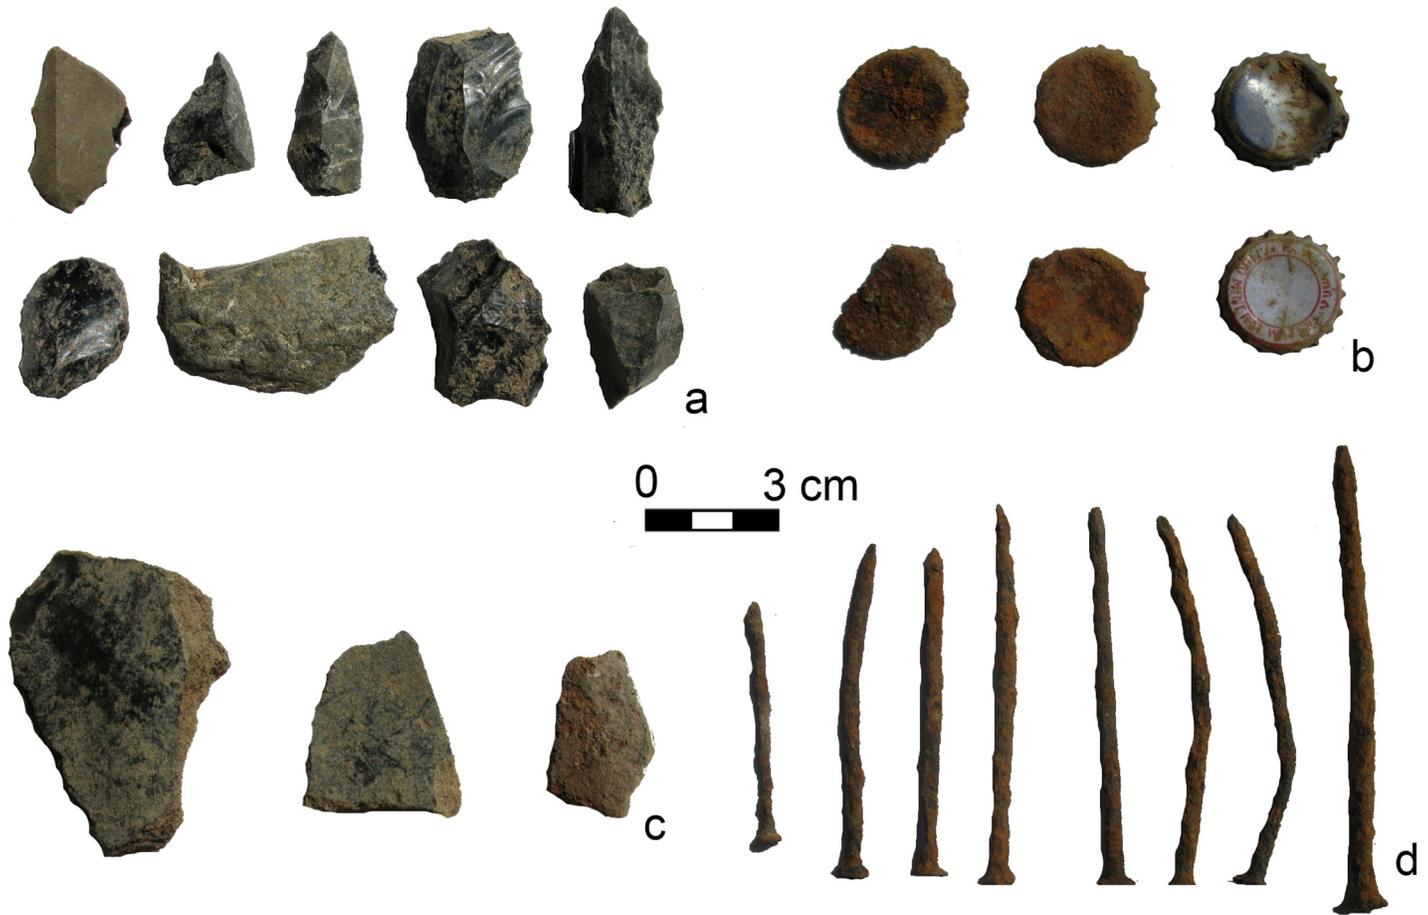
Figure 5: Materials recovered during our investigation: a) obsidian tools; b) metal bottle caps; c) potshards; d) iron nails.

We found 56 obsidian artifacts (Figure 5a), most of them tools produced in the MSA, the LSA and historical times; and 101 fragments of other volcanic rocks, 70 of them showing traces of human intervention in the Acheulean period and later. Only a few of the materials we gathered can be rightly attributed to the "historical" part of the *tukul*'s lifetime: two fragments of glazed tiles, six metal bottle caps (Figure 5b), eight iron nails (Figure 5d) and some wooden fragments, most likely from the building's frame. Three coarse potshards (one rim fragment and two side fragments, Figure 5c) are not diagnostic, hence they may date from before the camp was first built.

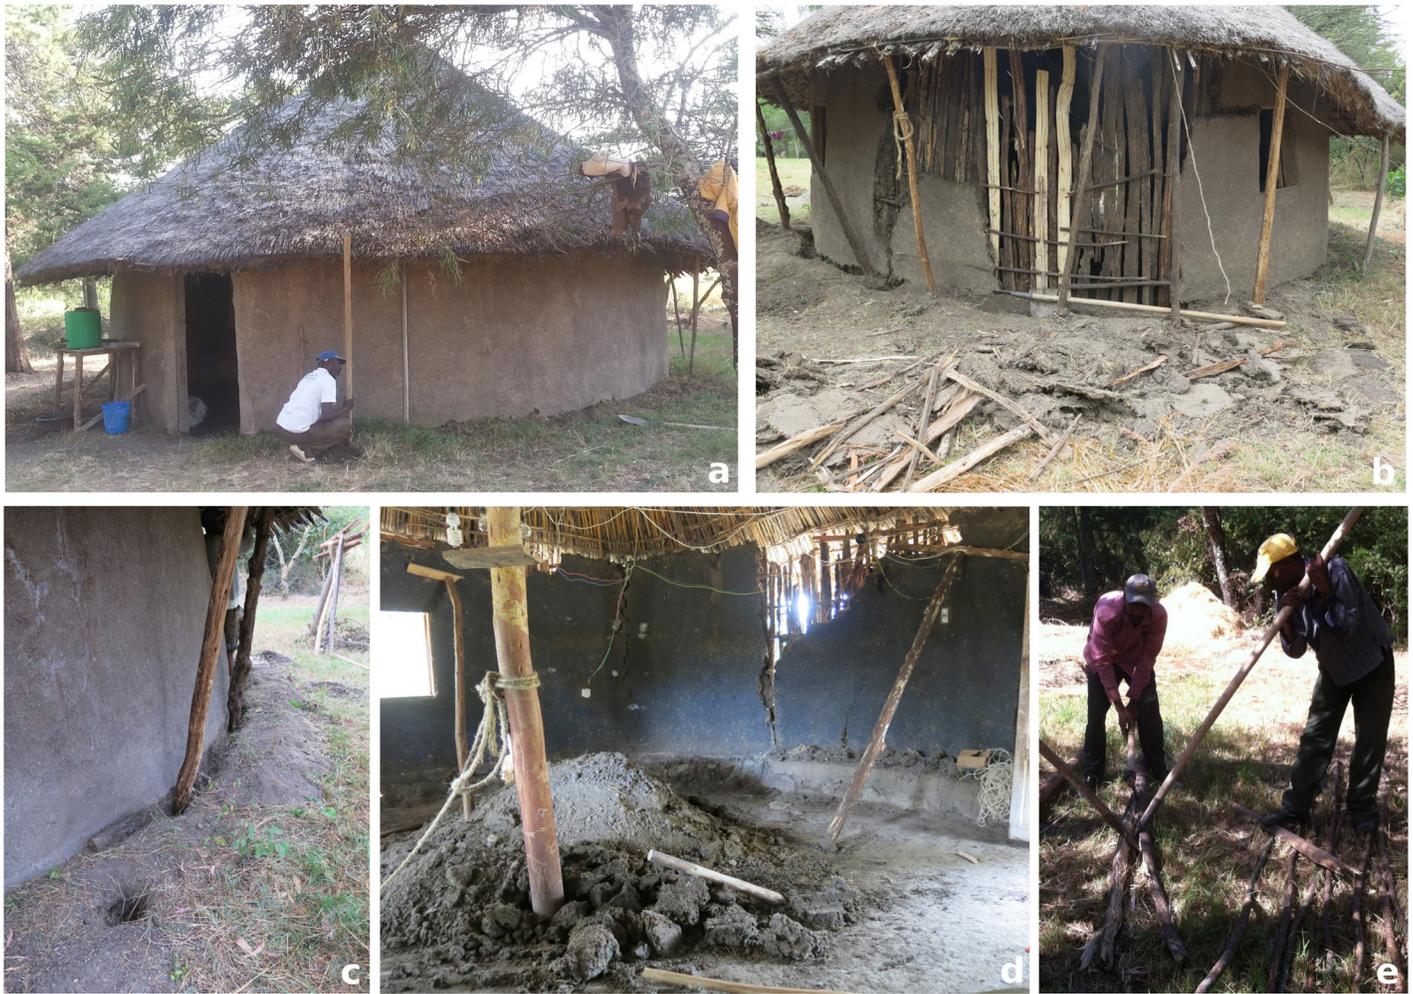
Figure 6: a) The camp’s main *tukul* (used as a dining room); b) the *tukul* during the initial stages of restoration, showing the temporary roof support, the detached daub and the wooden framework of the wall; c) detail of the temporary roof supports, showing the holes in which the poles were sunk and the ring of earth that accumulated around the base of the wall; d) the interior of the *tukul*, showing how fragments of the old daub accumulated on the floor; e) splitting poles for the new wall.

During the 2013 excavation season, we were able to watch local workmen restoring one of the buildings currently in use. It stands around 15 meters NE from where the old *tukul* stood, is used as a common dining and social room, and has the same features as the traditional hut described above (Figure 6a).

First of all, the wall had to be freed of the roof's bulk and weight. To do so, a narrow and shallow furrow was dug along the outside wall to expose its base. Next, round holes (15 to 20 cm in diameter) were dug at more or less regular intervals both inside and just outside the trench and poles were set upright in them, under the overhang of the roof. Because these poles were slightly longer than the ones that had been used to build the wall they raised the roof only a little, without detaching it from the central post inside the hut, thus serving as a temporary support structure (Figure 6b). One portion of the wall at a time, the thick daub layer was removed from both sides of the wall and the old frame replaced with a new one. The new frame was made of split poles about 20 cm in diameter (Figure 6e); these split poles were set upright along a furrow dug around the perimeter of the hut.

The restoration work led to the rapid buildup of a low ring of earth just outside the *tukul* (Figure 6c). The ring consists of sediment that had been dug up and fragments of the daub that had been detached from the wall. In some cases, the facing detached from the wall was used to fill the holes in which the temporary poles had stood. Inside the hut, the piling up of fragments of the old daub and the residue resulting from their grinding up for reuse and the spreading of the new daub on the wall resulted in the formation of a thin new layer of earth spread unevenly over the floor (Figure 6d).
